About the History of Idaho's Capitol

Phase One: The Central Portion (1905-1912)

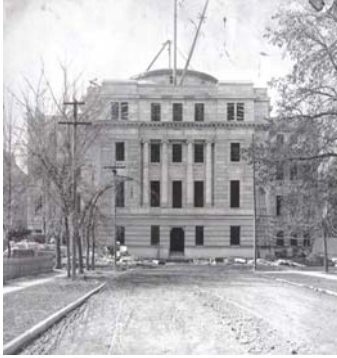
Once the exterior shell of the lower levels of the central portion was nearly complete, work began on the structure of the dome. In this construction photo of the north elevation, the derricks are in place for constructing the dome.

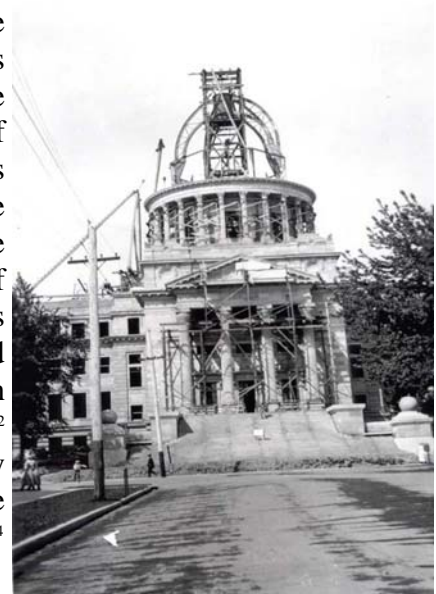
Layer upon layer, the dome rose above Boise in 1912. The sandstone columns of the peristyle encircle the dome’s steel drum, and above this the structural members of the dome begin to suggest the soaring height of the completed building.

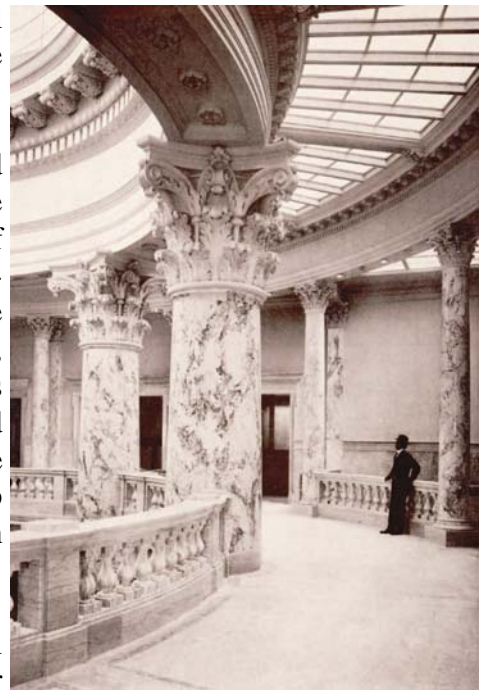
Skylights introduce the element of light into the fourth floor surrounding the rotunda.

Asserting the play of natural light in the building, skylights in the fourth floor ceiling illuminate the rotunda. The corners of the rotunda, above the staircases, are also lit from above by skylights. Additionally, four-story light shafts, located at the intersections of the rotunda and main
